2023 Basin Highlights Report

Texas Rio Grande Basin Program Update

**International Boundary and Water Commission, U.S.
Section**

Texas Clean Rivers Program

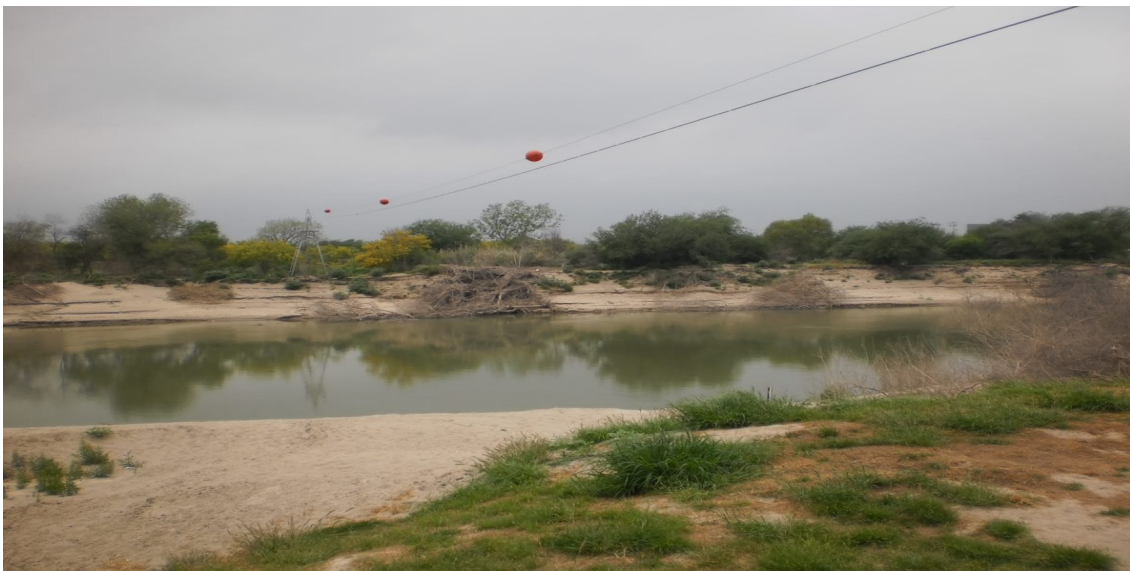
Pictured above at Los Ebanos showing gaging station.

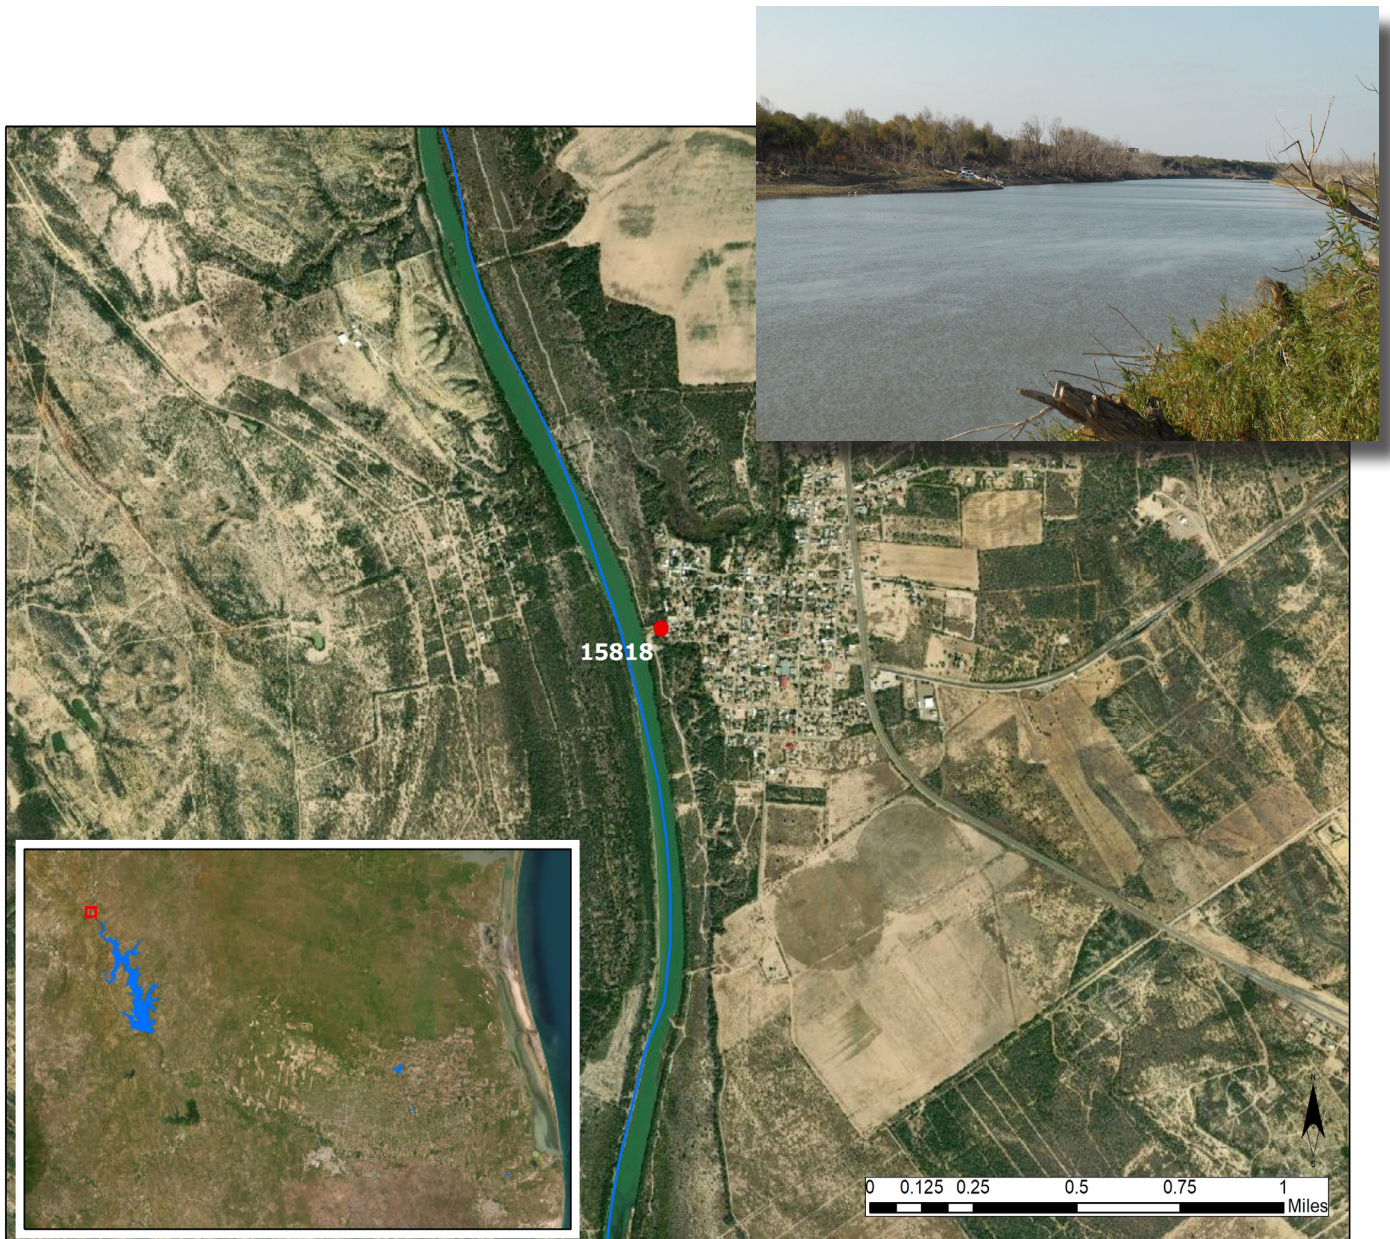
Small town of San Ygnacio to the right of station 15818. The Mexican side (to the left) shows no development. Station 15818 is located at the San Ygnacio WTP Intake West of US 83 Intersection with FM3169

For Station 15818, the mean of 8 bacteria samples of *E.coli* bacteria that were analyzed was 372 MPN. The site shows an increasing trend for high bacteria counts, which is likely due to the increasing population and recreation in the area. The data indicated that dissolved oxygen levels showed an average of 7.45 mg/L, but is showing a slightly decreasing trend. The water quality data for specific conductance shows a mean specific conductance reading of 972 uS/cm, and the average for pH at this station during the period of record is 7.5. Ammonia data for this station is an average of 0.19 mg/L and shows an increasing trend. Total Phosphorus is 0.21 mg/L, and this data shows a decreasing trend. The concern for toxicity in water has been carried forward in the last TCEQ Integrated Report, and more studies would need to be done to determine if this is still an issue.

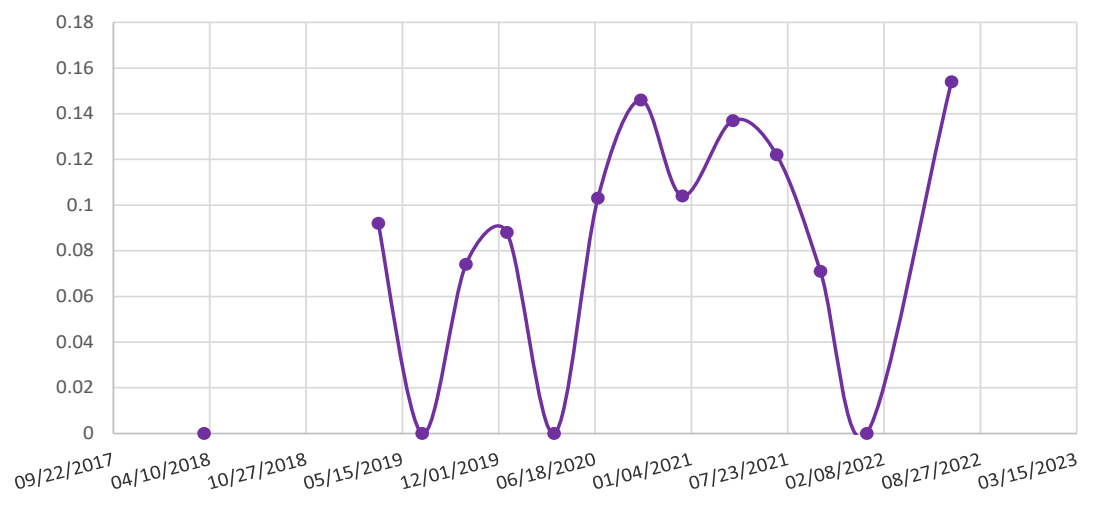
Graph to the left indicates Total Phosphorous results for station 13189 for the years between 2018-2022. Break in the graph indicates no available data.

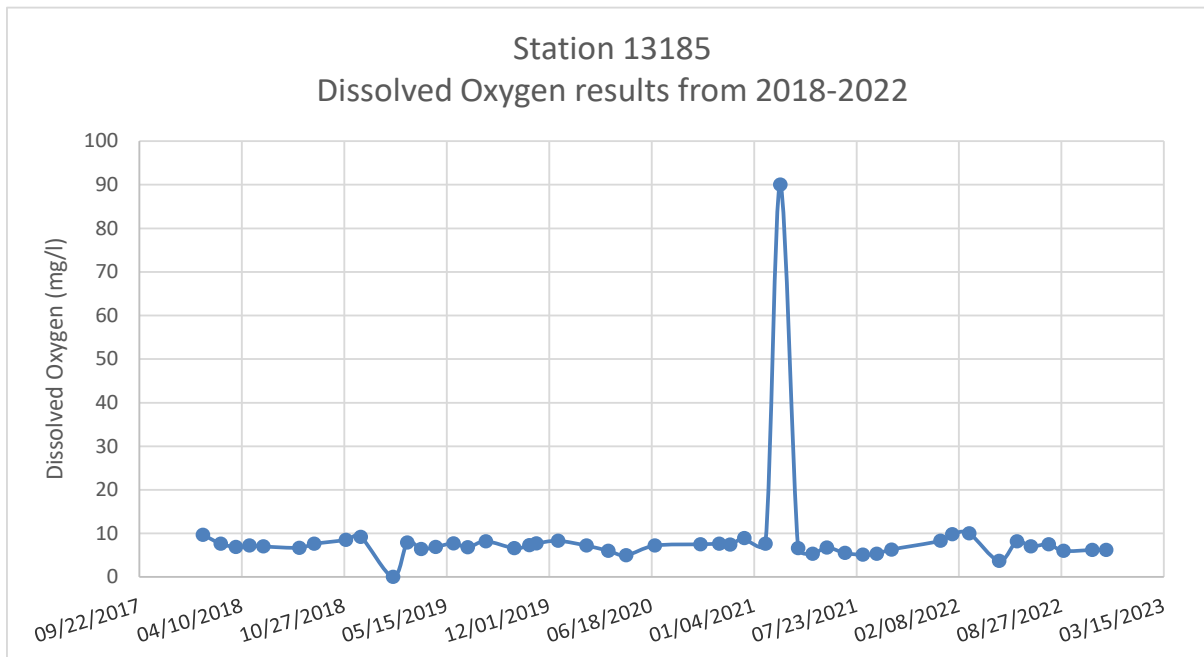
Graph to the left indicates Dissolved Oxygen results for station 13185 for the years between 2018-2022.

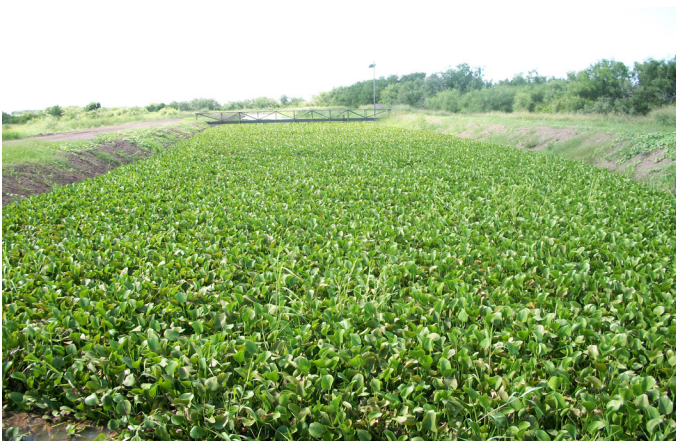
Pictured above are aquatic weeds, possibly hydrilla, completely covering a canal in the Lower Rio Grande Valley.

Infestations of invasive aquatic weeds such as hydrilla (*Hydrilla verticillata*), water hyacinth (*Eichhornia crassipe*) and giant cane have been problematic in the Lower Rio Grande Sub-basin. These aquatic plants obstruct sections of the river, prevent boat navigation, impede water flow, and increase water loss through consumption and evapotranspiration. However, control methods including mechanical removal and biological control using triploid grass carp have helped to reduce the problem.
