# 2010 Basin Highlights Report for the Rio Grande Basin in Texas

**International Boundary and Water Commission, U.S. Section  
Texas Clean Rivers Program**

April 2010

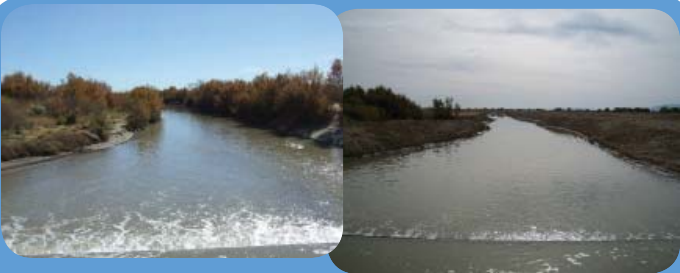
Station 15795 upstream of Fort Hancock, TX, before maintenance work (left) and after (right)

IBWC is continuing work under IBWC Minute 313 to maintain the river channel and floodplain from El Paso to Fort Quitman. Maintenance work is intended to prevent the international boundary from changing and to upkeep flood control projects.

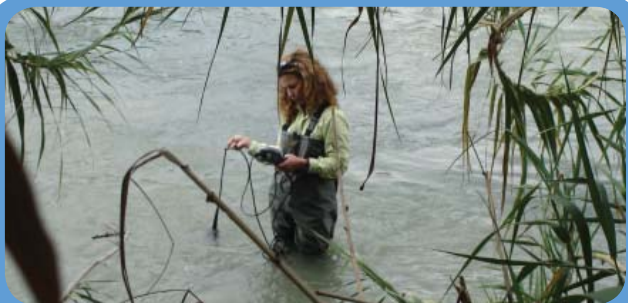
IBWC staff from Amistad Dam use a multiprobe instrument to collect field parameters such as pH and DO, downstream of Eagle Pass, TX, November 2009

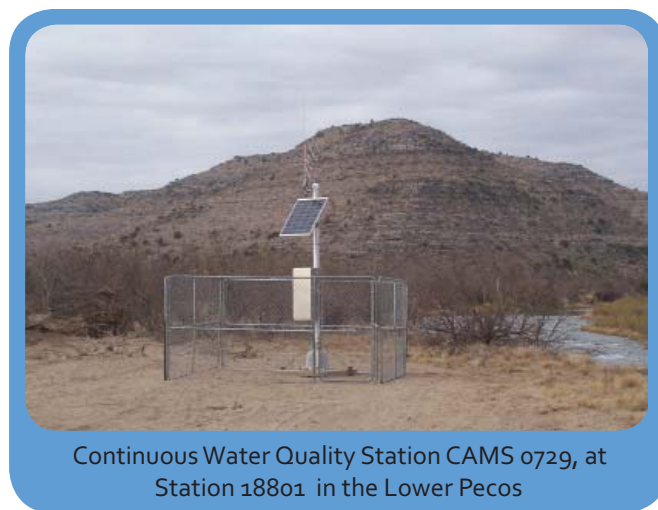
Continuous Water Quality Station CAMS 0729, at Station 18801 in the Lower Pecos
