# 2015 Basin Highlights Report

**Texas Rio Grande Basin Program Update**

**International Boundary and Water Commission, U.S. Section  
Texas Clean Rivers Program**

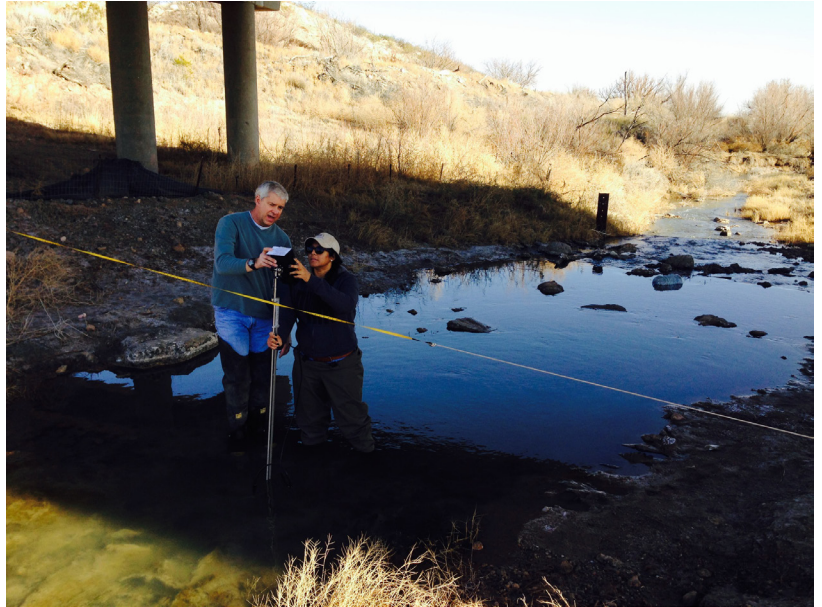
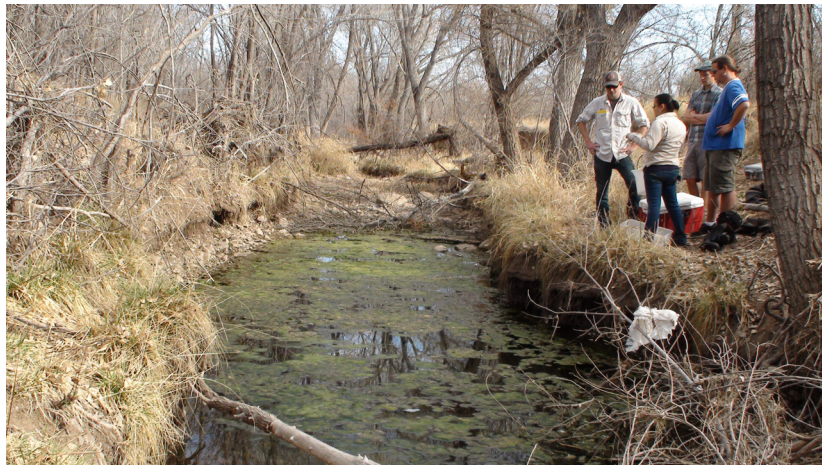
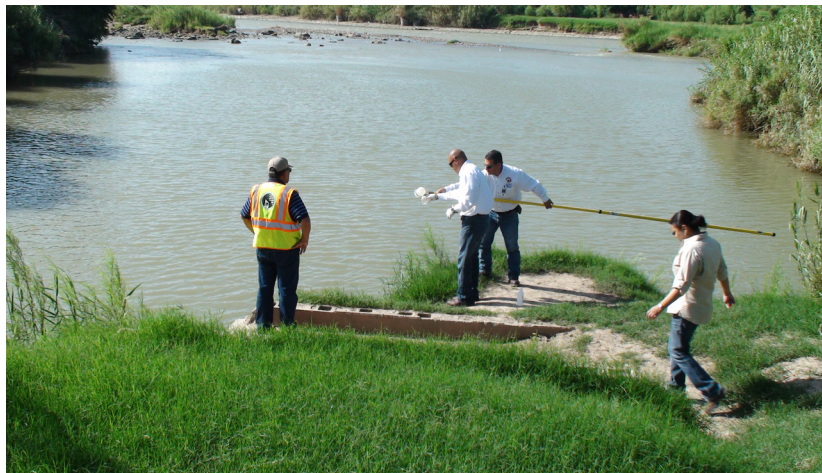
From top: Midland College, Laredo Health Dept, and Sul Ross partners sampling

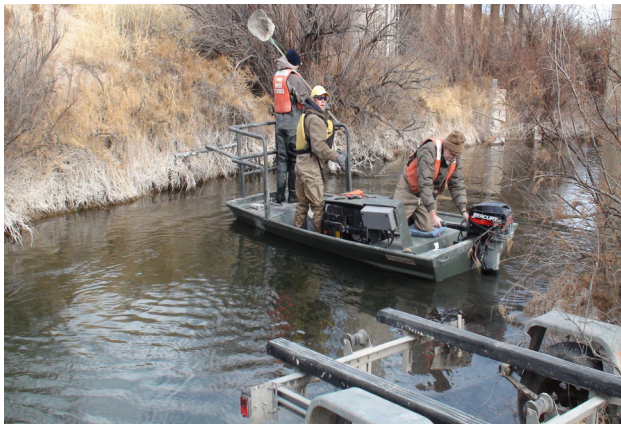
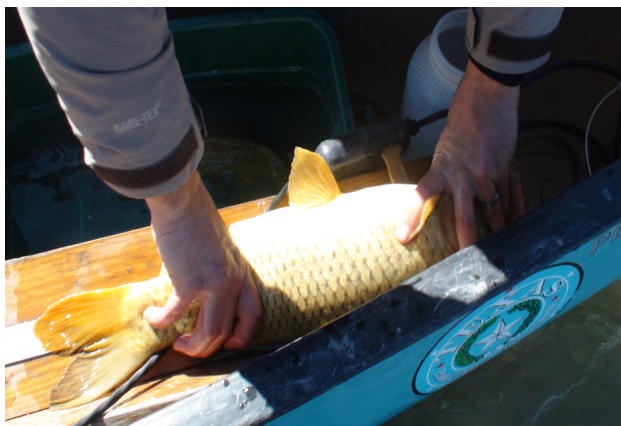
Aquatic life studies, such as this one in the Lower Pecos River, evaluate the health and diversity of organisms such as fish and insects that live in the water.
